DOT/FAA/CT-91/2

FAA Technical Center  
Atlantic City International Airport  
N.J. 08405

# Development and Growth of Inaccessible Aircraft Fires Under Inflight Airflow Conditions

Final Report

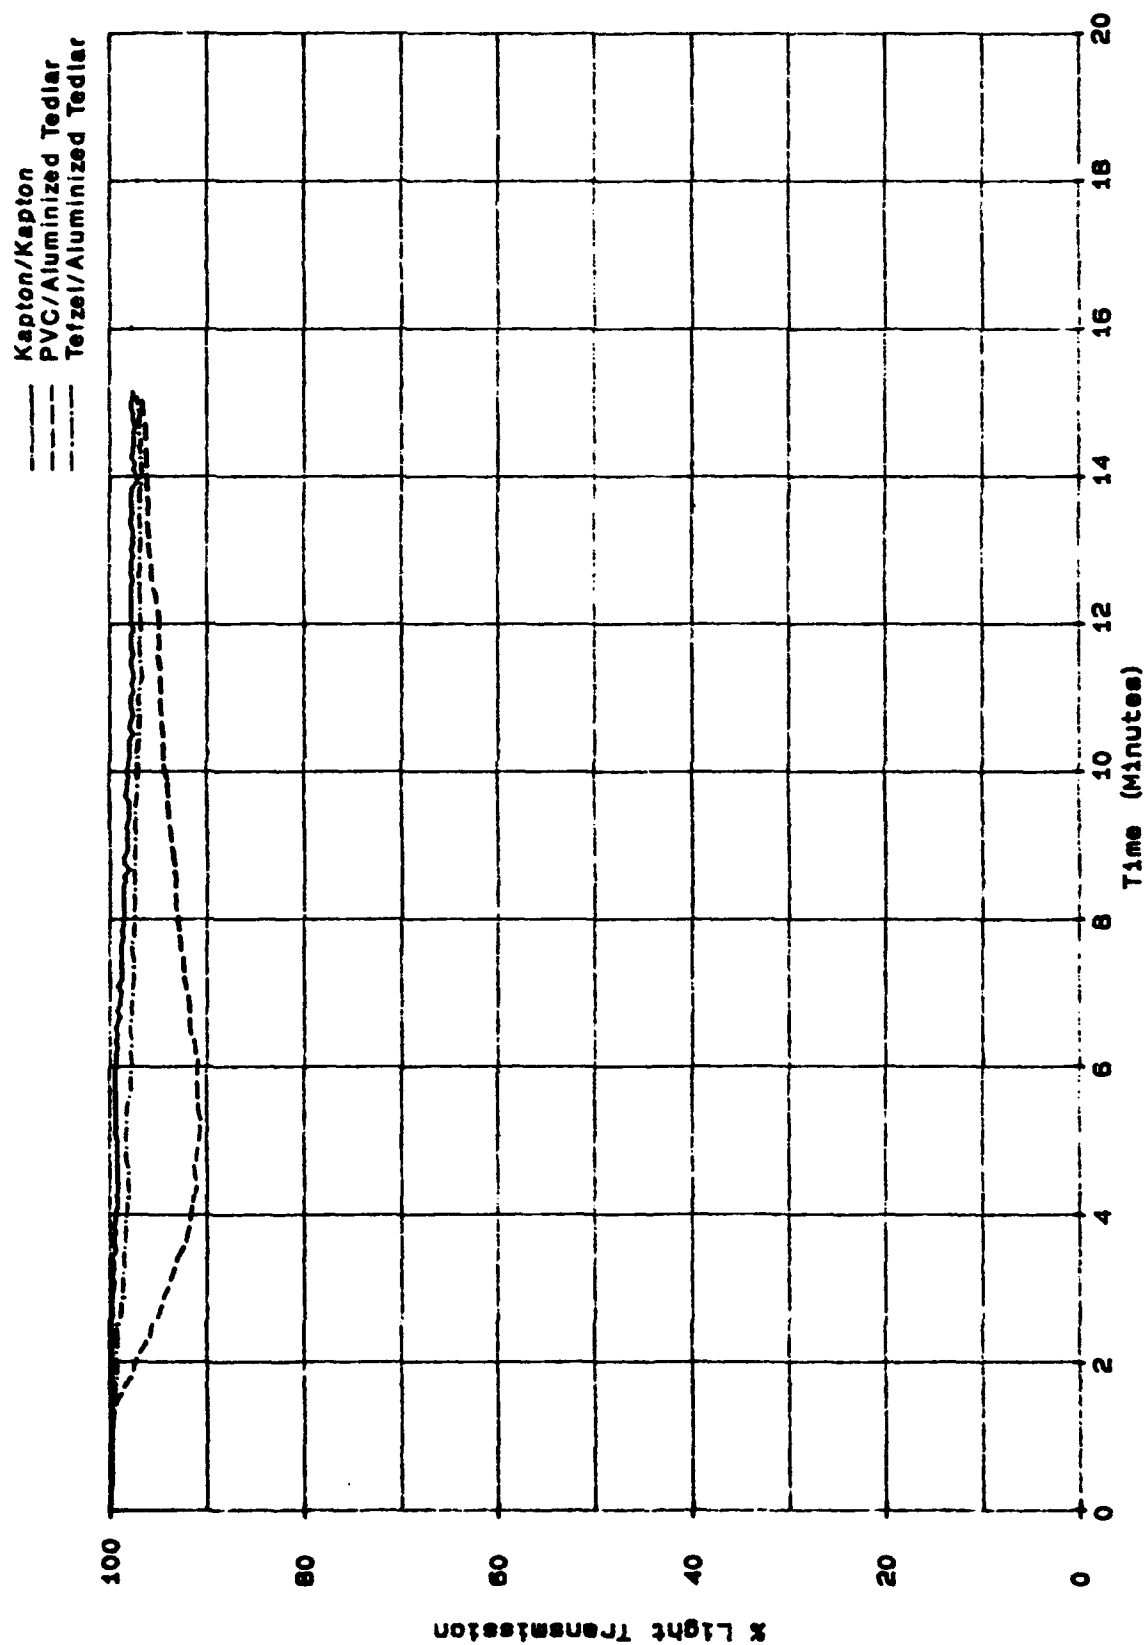
FIGURE 15. MID CABIN AVERAGE SMOKE LEVELS--TESTS 31, 32, AND 33

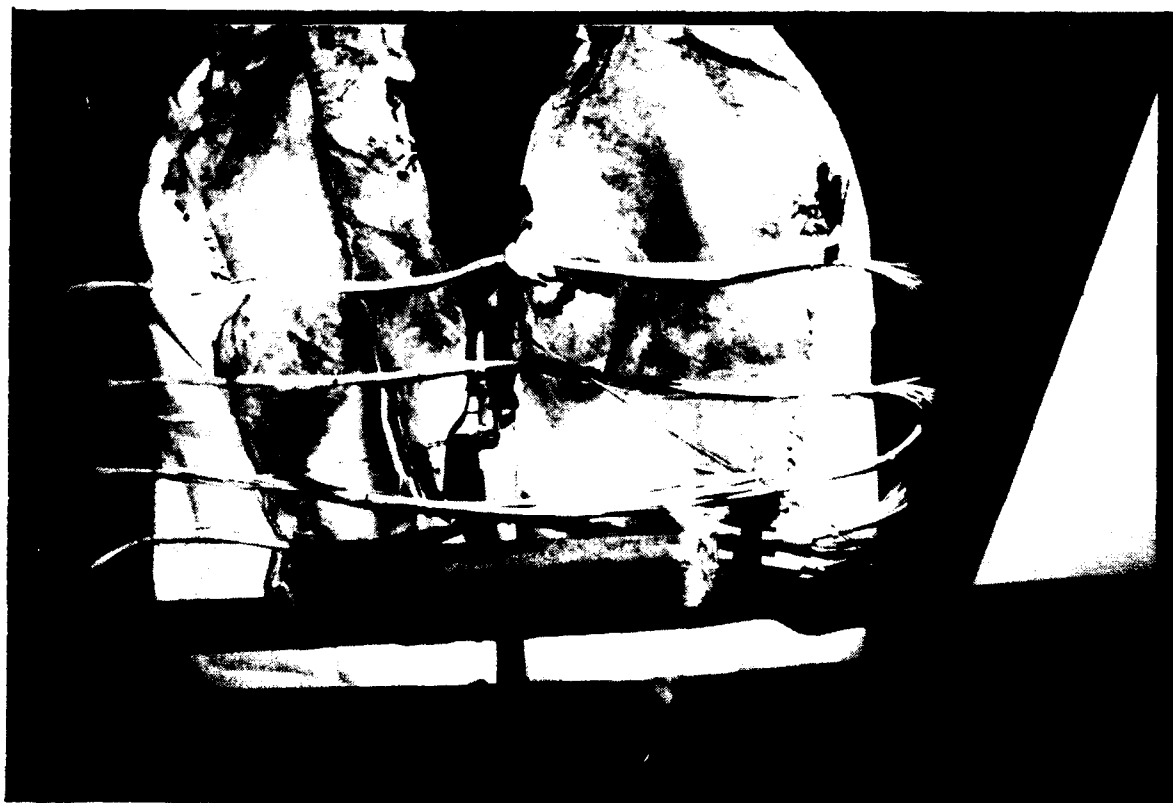
FIGURE 18. WIRE AND INSULATION BEFORE AND AFTER-TEST 33  
(Tefzel Wire Insulation/Aluminized Tedlar Covered Batts)

Test 32, with PVC wire and aluminized Tedlar insulation batts, produced significantly more smoke and heat than tests 31 and 33. Figure 13 shows the average temperature above the cabin ceiling for the three tests. The temperature is the average of the six thermocouples in the 950-cubic-foot space above the ceiling. Figures 14 and 15 show the average smoke levels for the three smoke meters above the ceiling and the three smoke meters in mid cabin. It can be seen from these graphs that the main source of smoke and heat in test 32 was from the PVC wire insulation, since test 33 used the same aluminized Tedlar insulation covering as test 32 but produced much less smoke and heat. A PVC/nylon wire insulation will not pass the current flammability test for aircraft wiring which was imposed in 1972. However, it was installed on some aircraft manufactured prior to that date, many of which are still in service. Kapton and Tefzel insulated wires do pass the current flammability test. Figures 16, 17, and 18 show the wire bundles and insulation before and after each of the three tests.
